Guide for checking the back focus linkage on the Pro35

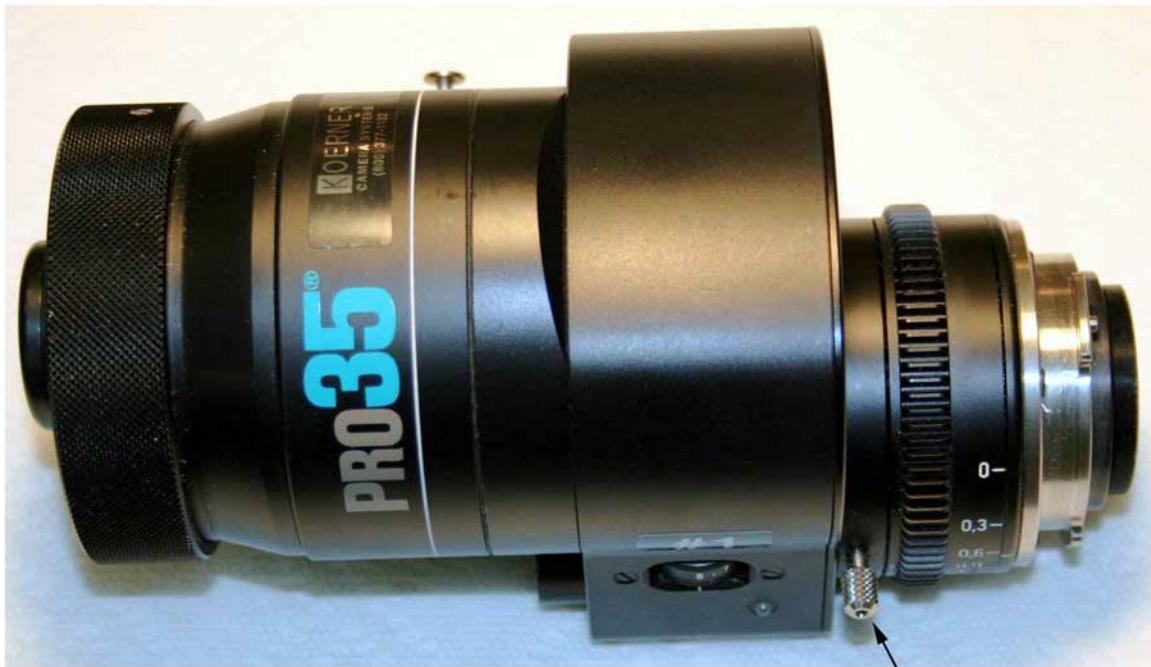
Back focus adjustment lever

If the back focus adjustment has play and focuses the image in two different positions depending on the direction of rotation, the linkage may be loose and needs to be checked. The following description will guide you through the process. The work is fairly easy and does not involve critical optical adjustments. You will need some small Metric hex wrenches.

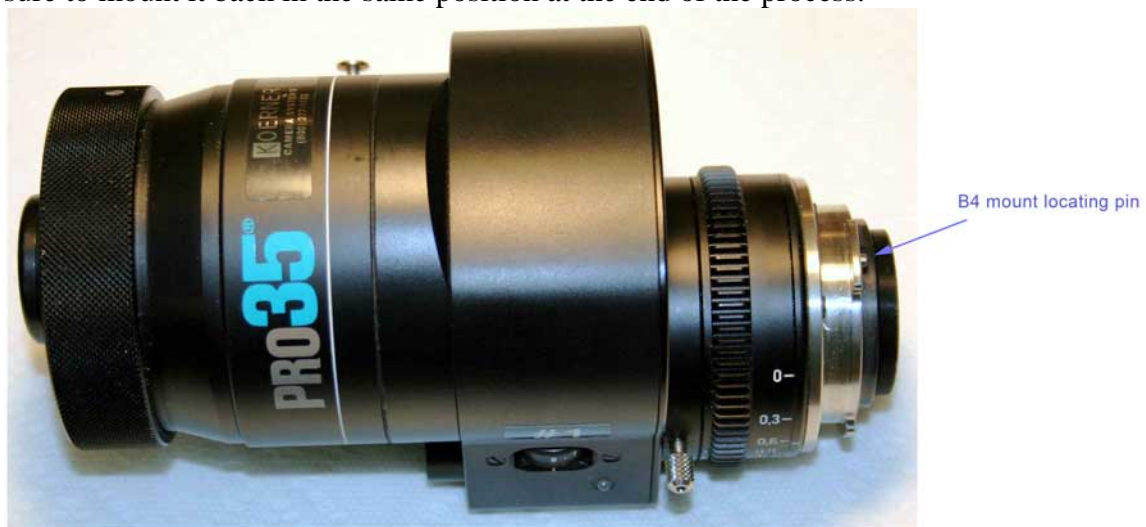
The mount had to be removed but first note the position of the locating pin so you can be sure to mount it back in the same position at the end of the process.

Removing the B4 mount is a matter of removing 6 screws using a 2mm hex wrench

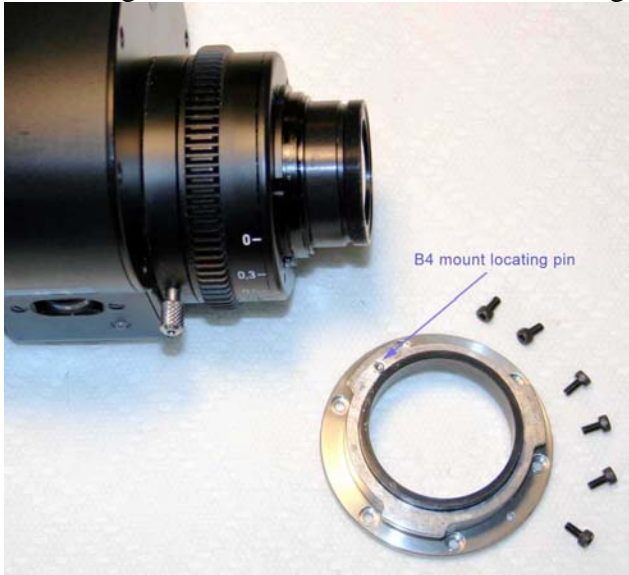
Next the backplate comes off with 5 slotted screws.

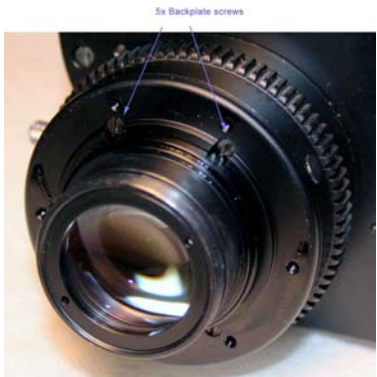
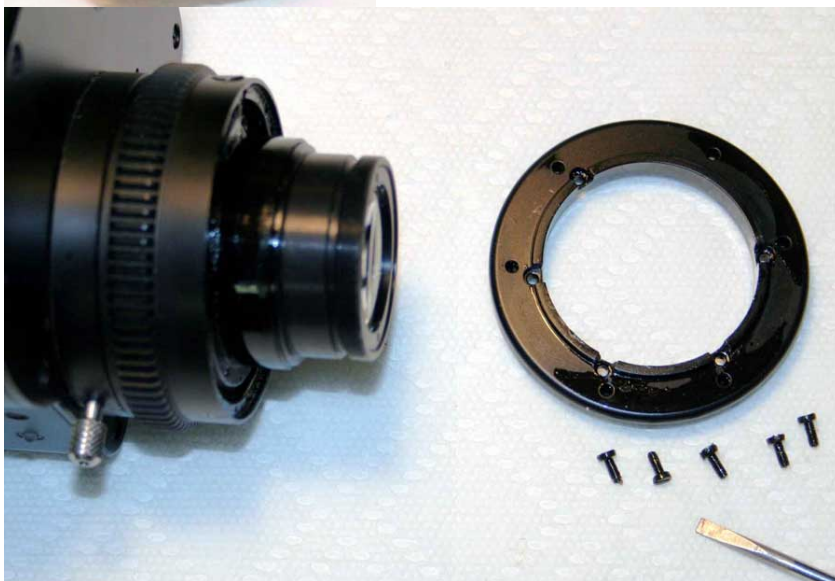
To remove the iris ring, the iris lever has to be removed and for that the cap has to be unglued.

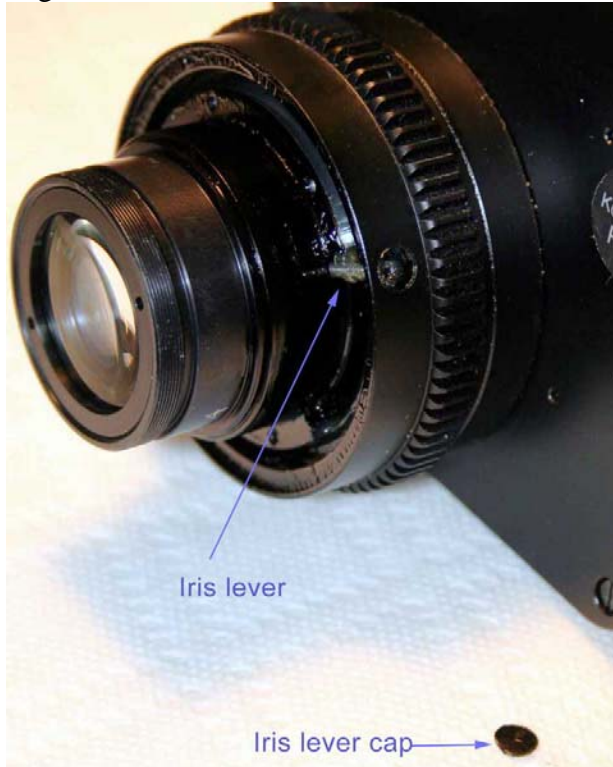
The iris lever is a long threaded part that can be unscrewed with a small screwdriver. For re-assembly, it is not too difficult to screw back in place if the iris is in the fully open position prior to disassembly.

The lever can then be leaned on the metal stop to line it up with the threaded hole on the iris body.

The iris ring slides off the relay once the lever has been removed.

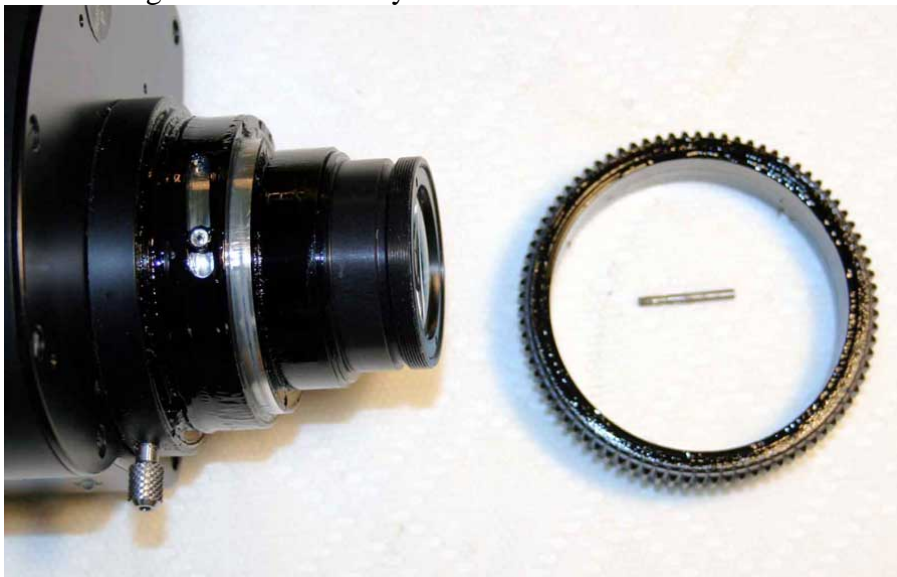
We now have a view of the linkage that is likely to be at the origin of the trouble with the back focus play.

There are 2 cam followers (one on each side).

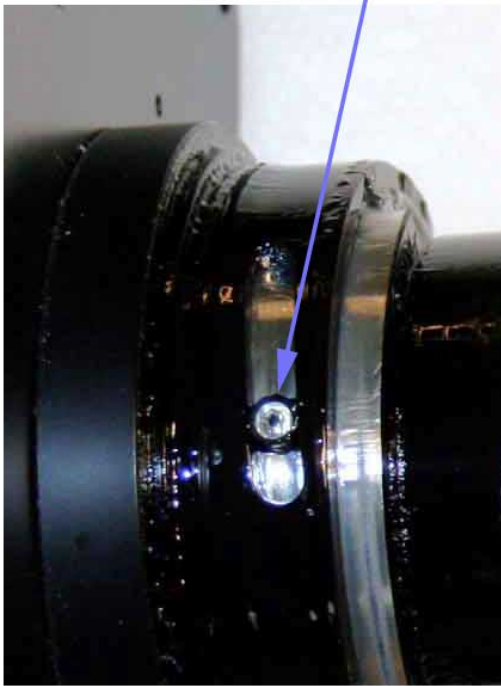
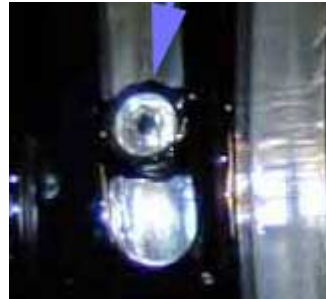
Cam follower

In the middle of the cam follower there is a hex head screw that needs to be tightened. Be careful to not over tighten it however but it should not be loose either.

A small amount of torque applied with a 0.89mm hex wrench is all that is needed. Check both sides and you are ready for re-assembly.
